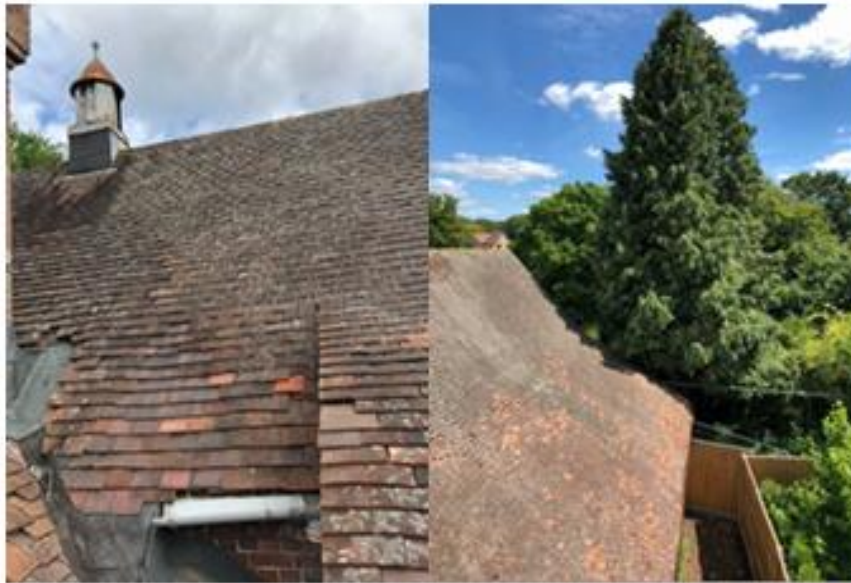
Existing school roof condition: Facing south

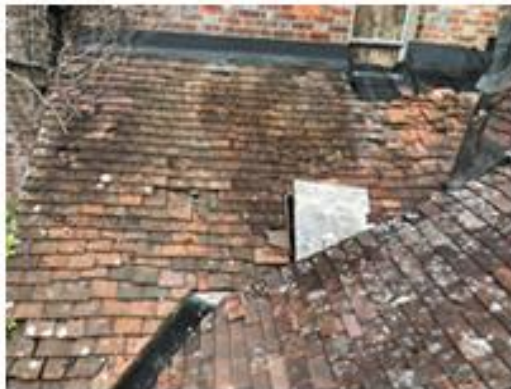
Roof junction with rear of house.
