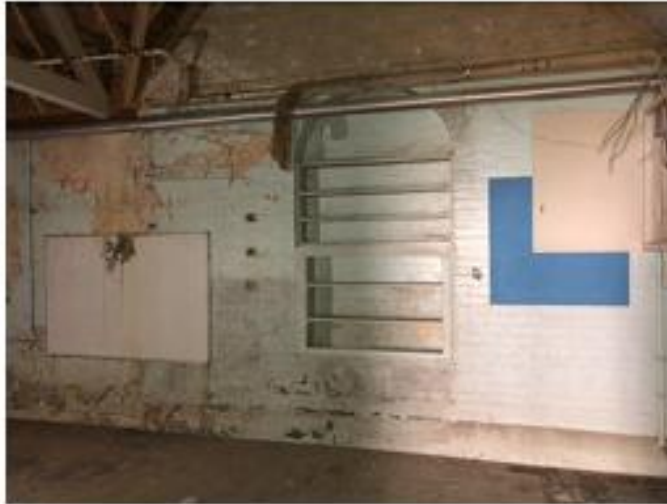
School interior to party wall with house. Note oil feed pipe running full length of school to oil tank in rear garden. (Oil tank to be drained and demolished.)

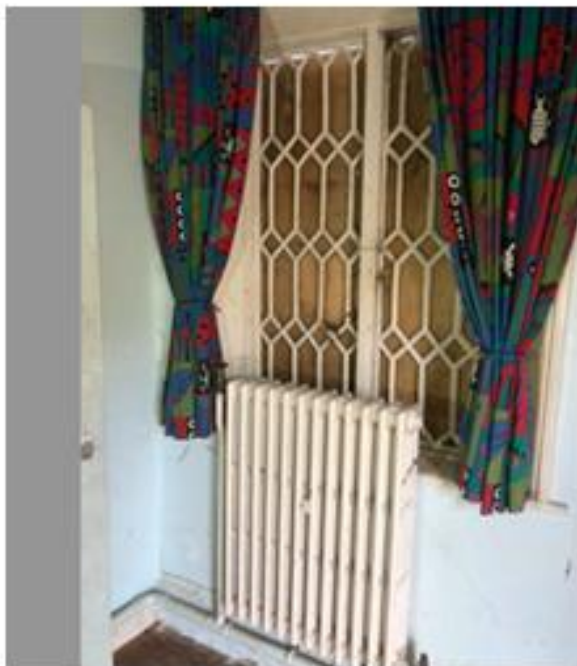
Only existing one of three original cast iron lozenge design front windows to front façade. Replacement required for original two missing windows to match existing for Grade 11 building.
